# Condition Assessment of Metsimothabe River Bridge using Non-Destructive Testing and Non-Contact Procedure

A process of in-service infrastructure health assessment using non-destructive testing and evaluation (NDT&E) techniques is crucial for prompt, accurate and quantitative identification of damage in civil infrastructure. The aim of this study was to assess the structural performance of Metsimothabe River Bridge through NDT&E and load testing techniques. Schmidt rebound hammer was utilized to determine the compressive strength of the bridge, total station was used to monitor the profile of the bridge girder level for differential deformation, and a non-contact global positioning system (GPS) technology was employed to measure the dynamic displacement of the bridge under random operational traffic loading conditions. Finally, the dynamic behavior of the bridge was evaluated based on displacement, strain and acceleration response data. There was a perfect linear correlation between rebound number and compressive strength of concrete from different contact surfaces. The compressive strength of the bridge superstructure from random sampling was 39.48 N/mm<sup>2</sup> (CoV = 19.22%

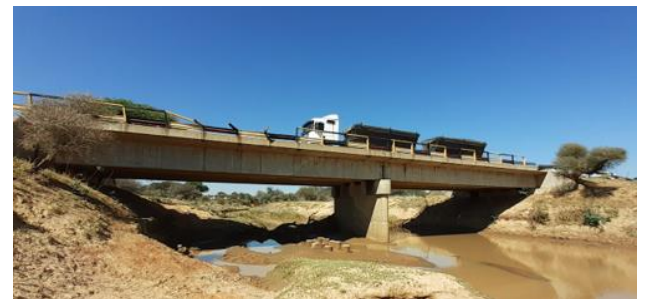
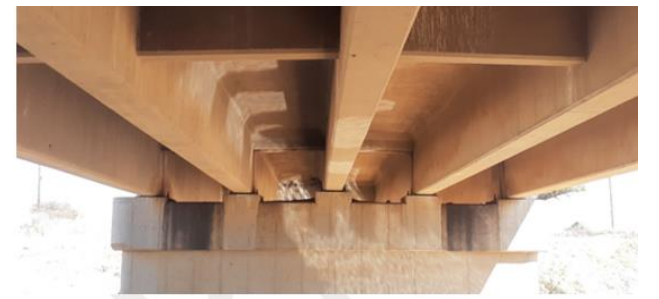
The bridge consists of two spans simply supported RC beam and slab supported on a wall type solid pier. The total span is 42.6 m and total width is 12.1 m. There are 1.5 m wide walkways on either side of the roadway with steel railing parapet. Each span length is 21.3 m comprising five girders spaced at 2.1 m centers. The width and overall depth of the girders are 400 mm and 1500 mm respectively. There are two wall type abutments and RC wall pier. Deck construction method is cast in-situ on stationary false work and the bearing type is elastomeric, teflon and stainless-steel plates. The vertical alignment of the bridge is at a constant gradient of 0 to 2%, horizontal alignment is straight, camber/cross fall is 2 to 4%, and the angle of skewness is zero degree. Minimum vertical clearance is 6.5 m and the bridge altitude is at 900 m above mean sea level. The surface on deck and approaches is asphalt. Figure 1 illustrates the bridge elevation, underside and profile section.

**Figure 1.** The elevation, the underside view and cross-section of Metsimothlabe Bridge

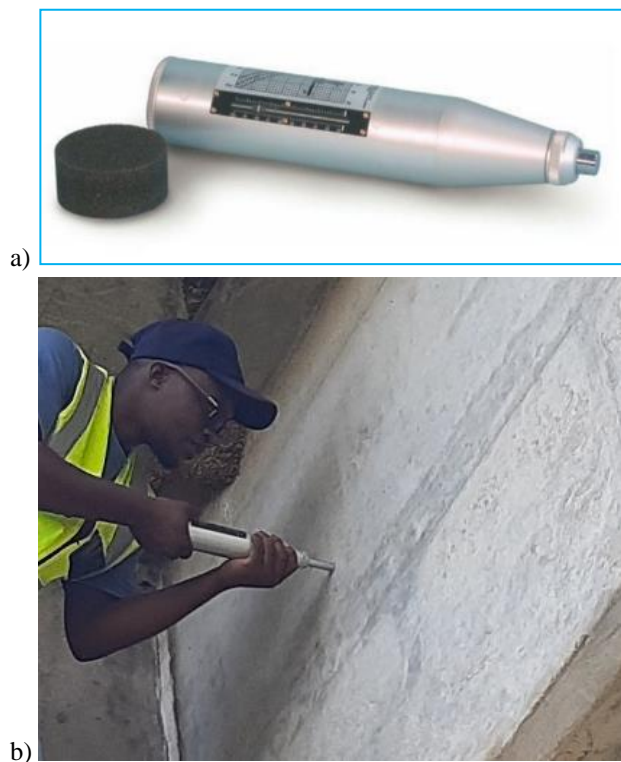
The effectiveness of Schmidt hammer in determining concrete compressive strength of the bridge superstructure was implemented in accordance with EN 13791 (2007) and EN 12504-2 (2021). The impulse test hammer (rebound hammer) is a simple, quick and inexpensive to use and was calibrated with a total of 36 precast concrete cubes of different predetermined compressive strengths between 20 and 35 N/mm<sup>2</sup>. The N Type MH-75 model Concrete Test Hammer (Schmidt Hammer) was used as shown in Figure 2 together with the on-site test process. Prior to field test, the rebound hammer was calibrated to establish the relationship between compressive strength and rebound number.

**Figure 2.** (a) N Type concrete test hammer and (b) on-site test process

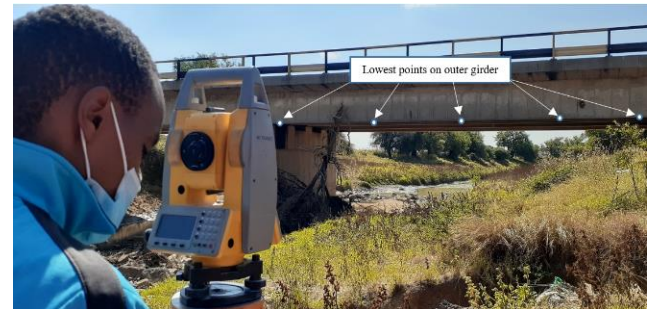
A Hi-target ZTS-420R total station with absolute encoding measurement method was used on Metsimotlhabe River Bridge to determine the bridge elevation in order to quantify the permanent vertical displacement measurements of the deck. For on-site

deformation monitoring, 10 monitoring points, A1 to A5 and B1 to B5, spaced at 5.325 m at the northern and southern sides respectively were marked on the external bridge girders as shown in Figure 3. Two control points were also established and fixed on stable ground on either side and away from the bridge. Three observations of data for each monitoring point were undertaken to minimize measurement errors.

**Figure 3.** Bridge data collection using the Hi-Target total station

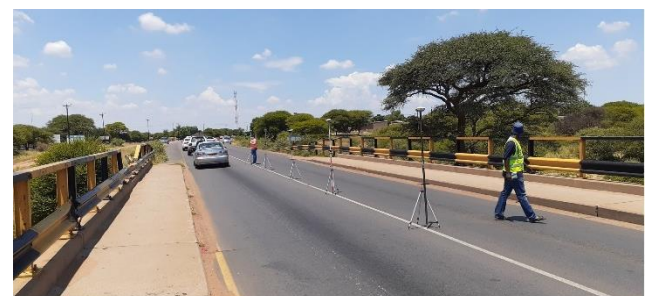
Real-time kinematic (RTK) dynamic displacement data of the bridge girder under random traffic loading was monitored using GPS survey equipment at a sampling rate of 10 Hz. Five rover observation stations were each considered along the center-line of the bridge as depicted in Figure 4. Each rover station was observed for about 15 minutes for each cycle. On the observing point, the GPS antenna was placed vertically on the bridge surface, which reflects the movement of the bridge completely. Three sets of data were collected and pre-processed using GPS-Trimble software in the analysis. The output of the GPS software was the time series of the instantaneous Cartesian coordinates of the rover receiver in the World Geodetic System (WGS84) coordinate system.

**Figure 4.** Field data capturing using GPS receivers

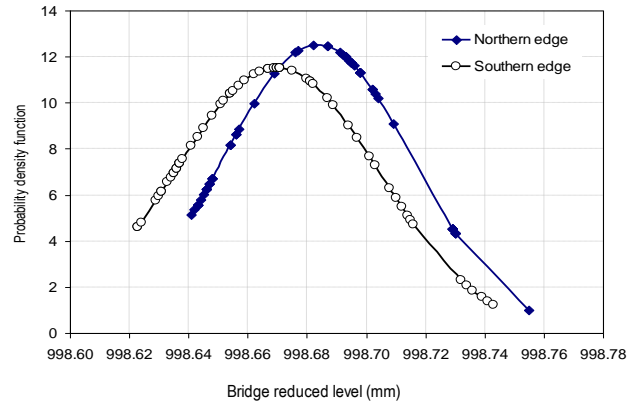
The reliability of the data of the bridge profile was ascertained by a set of random data analyzed to determine its variability where the traditional statistical functions, mean, standard deviation and coefficient of variation were estimated. In addition, as shown in Figure 6, the results show that the north and south profile data is normally distributed. The bridge levels data depict similar results.

**Figure 6.** Normal distribution graph for north and south edges data.

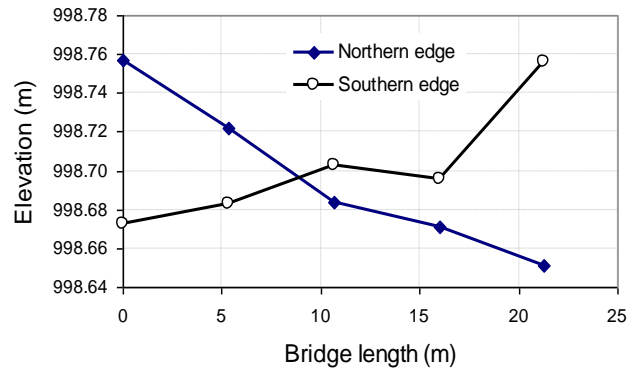
It is evident from the bridge level readings at the northern and southern edges that slight torsional deformation exists on the girder-deck structural system. The southern edge is slightly higher from levels 998.62 m to 998.67 m, while the northern edge is higher from levels 998.67 m and above. The percentage difference between the average levels of the northern and southern edges of 0.0014% was numerically very negligible. Further assessment of the levels of the northern and southern edges at common chainages verified the tendency for torsional deformation.

Bridge data results measured at five different locations on the bridge girder namely the two supports, two quarter spans and the mid span as shown in Figure 7. The measurement data were taken on the southern and southern sides or edges of the bridge.

It was observed that the levels of the girder/deck connections on the northern and southern edges revealed differential displacement which was a clear indication of torsional deformation of the bridge superstructure. It can also be observed that the northern edge was relatively highest at chainage zero with a differential of 84 mm and decreased to 39 mm at one-quarter span point. However, there was a progressive twist on the southern edges which increased from 19 mm at the midspan, 25 mm at the three-quarters span and highest at the support at a differential level of 105 mm. These results had confirmed the initial

observation and suspicion of torsional deformation. Bridge deck is usually under flexural stress due to traffic loading and possible differential settlement of supports. The bridge insignificantly slopes from the embankment towards the center pier support with the calculated slope of 0.1%.

**Figure 7.** Bridge level at the northern and southern edges of bridge length

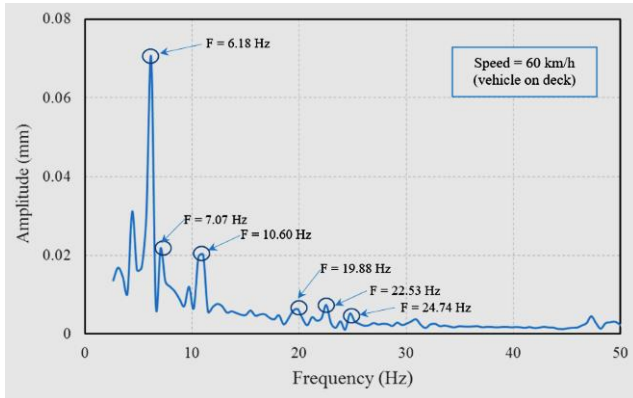
The frequency spectra of the displacement time series for the bridge are shown in Figure 8 for the forced vibration under the moving truck and in Figure 9 for the free vibration of the bridge after the vehicle had left the bridge. It is evident from Figure 8 that the frequency spectra were masked with noise because of interference of the vibrations of both the bridge and the moving vehicle thereby producing many peaks around the natural frequencies of the bridge structure. On the other hand, Figure 9 shows the unambiguous frequencies of the bridge

**Figure 8.** Frequency spectrum for the loaded bridge under moving vehicle at 60 km/h ( $F = 6.18$  Hz)
