Flexural Behaviour of Concrete Beams Reinforced with Major Steel Bars under Normal and Corrosive Operational Conditions

Adekunle P. Adewuyi

Department of Civil Engineering, University of Botswana, Gaborone, Botswana

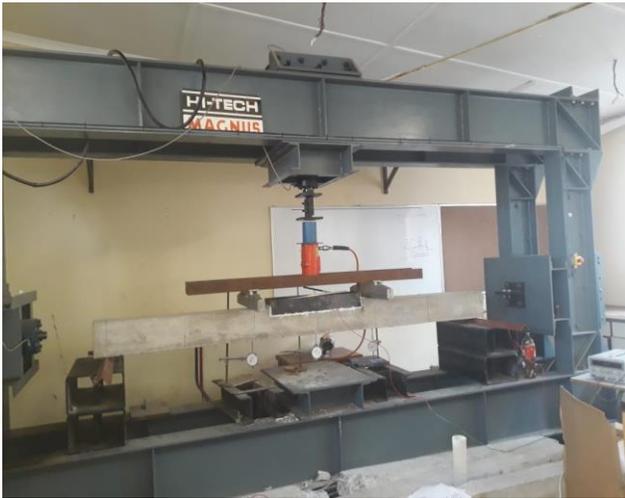
Figure 3. Pond placed and sealed at the center of the beam for accelerated corrosion.

A pond of size 150 × 700 × 50 mm placed at the top of the middle-third of the beam and containing 5% sodium chloride (NaCl) solution to accelerate corrosion process of the RC beams. A stainless-steel cathode was fixed on top of the beam over the length of 700 mm as shown in Figure 3. The brine, that is NaCl, solution was changed after every 3 hours to maintain the concentration of the aqueous solution. After sixty hours, dial gauges were set to zero, took off the pond and tested beam for flexural behaviour by loading beams at intervals of 0.25 tons using a hydraulic jack. Current-induced corrosion flowed from the positive terminals of the DC power supply to the tension reinforcements, and then through the saturated concrete

and sodium chloride solution to the stainless-steel plate which was connected to the negative terminals of the DC power supply. Tests were run by monitoring sustained load first for 60 hours to ensure that corrosion initiation takes place. Deflection and cracks of the RC beams were monitored under the sustained load.

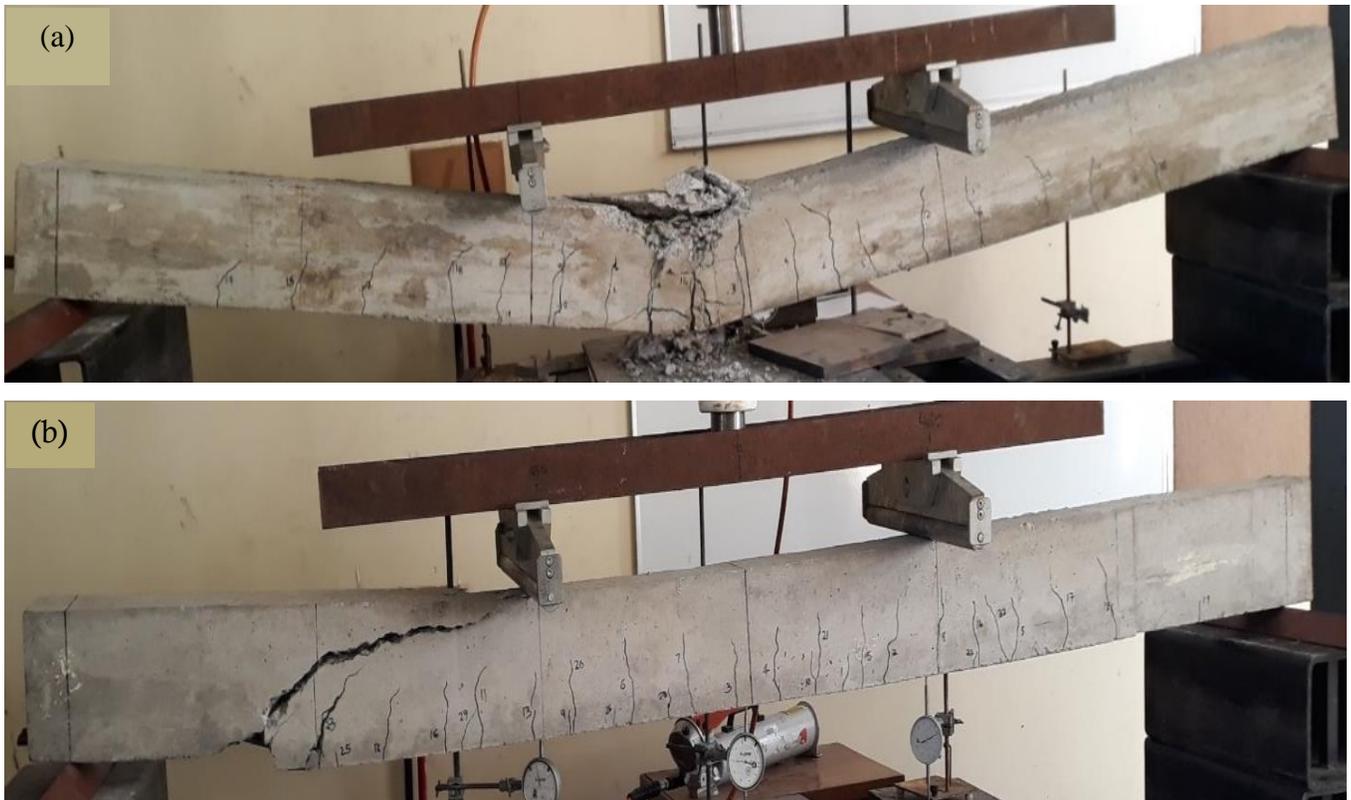
Figure5. Flexural test failure patterns of controlled specimens of RC beam reinforced with (a) M1 and (b) M2 at ultimate failure

The mode of ultimate failure of B-M1 was flexural tension failure with crushed concrete in the compression zone. However, beams B-M2 had diagonal shear tension failure as shown in Figure 5. For the flexural failure scenario, there was a progressive deflection which began as a set of parallel tiny vertical cracks that progressed as the beam was subjected to a gradually increasing load and terminated as crushing of the concrete within the vicinity of the point of maximum moment (Li et al., 2018). However, in the case of shear mode of failure, the first crack appeared vertically on the side surface at the midspan of beams. As the load increased at a slow, but constant rate, inclined or diagonal cracks were initiated at the shear-flexural zone near the support point, which incidentally the point of maximum shear, and gradually progressed toward the third point of load application.

The ultimate failure occurred quite suddenly as the inclined cracks widened up from left end of the support and propagated towards the point of load application by the roller at the third point of the beam. The results of shear failure could be related to point load being shifted to the left since the load was applied manually by the jack. The shear span to depth ratio was higher which supports that the reinforcement used was sufficient to resist shear (Abigaz, Liu & Yilachew, 2021). The shear failure could be related to reinforcement that was used for shear, had low rib height and no gaps which could temper with bond between concrete and reinforcement.
